Adhesive Bond Failures in Aircraft Honeycomb-Sandwich Composites

T. R. WALTON AND J. E. COWLING

June 15, 1970

NRL Report 7077

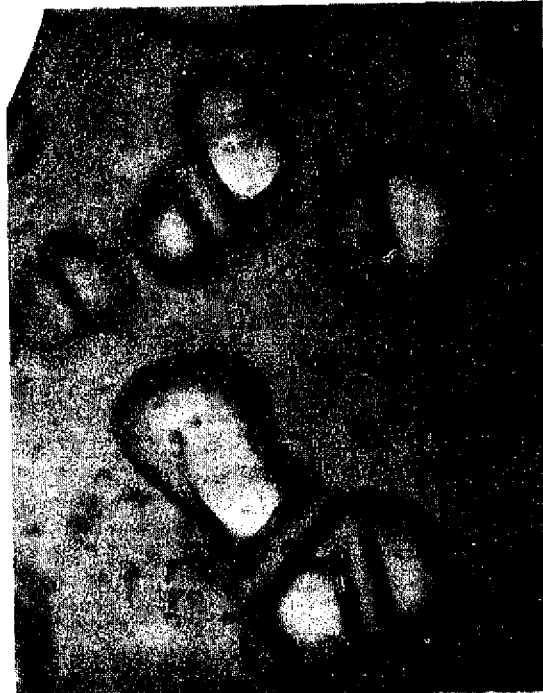
Fig. 2 - Photomicrograph from the epoxy side of the epoxy/glass interface showing the epoxy/nylon-cloth/nitrile-elastomer composite adhesive. Bonded between two microscope slides at 350°F and 15 psi pressure. (100X; transmitted light.)

One of the first observations was the fairly large difference in the flow characteristics of the two adhesive resins, the modified epoxy and the nitrile elastomer. Under the recommended bonding conditions of pressure and temperature, much more epoxy resin is squeezed out of the bond line than nitrile elastomer. As a consequence, the resin thickness on opposite sides of the nylon cloth will be different. In fact, as the epoxy resin is squeezed out, the nylon cloth is pushed to, or close to, the interface of the resin and glass adherend. Close examination of the epoxy side of the composite adhesive (Figs. 1 and 2) reveals the presence of nylon filaments at or near the glass/epoxy interface. Another important feature, obvious in these two photomicrographs, is the presence of entrapped "air" bubbles. The odd shape of some of these results from the nylon filament running through or forming a boundary on the edges of the bubble. It also can be observed that a number of these air bubbles or voids are interconnected by the nylon filaments.

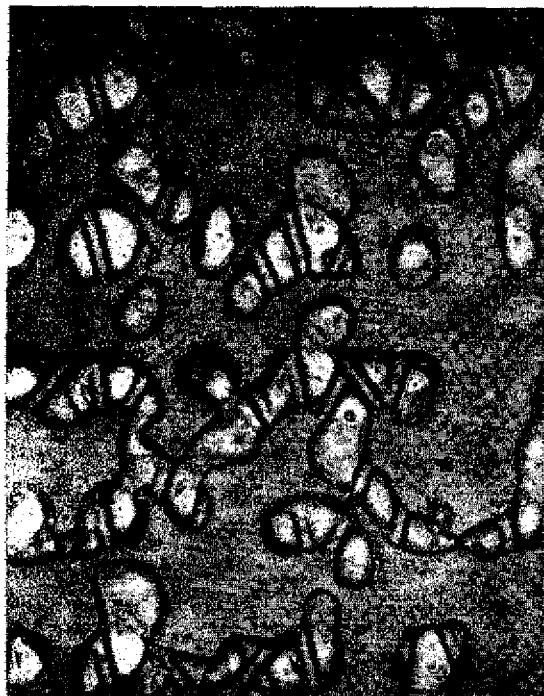
Fig. 3 - Photomicrograph from the epoxy side of the epoxy/glass interface showing the epoxy/nylon-cloth/nitrile-elastomer composite adhesive. Bonded between two microscope slides at 350°F and 15 psi pressure. (40X; transmitted light.)

Figure 3 is a photomicrograph taken at lower magnification and shows the wide distribution of "air" bubbles in the adhesive. Figure 4 is a good picture of the features in the interface, although it is a somewhat misleading view in that the areas that appear high (closer to the observer) are actually below the areas that appear lower. Thus, the entrapped "air" bubbles appear to be rising out of the adhesive at its interface with the glass. This is not the case and the illusion results from the transmitted oblique lighting.

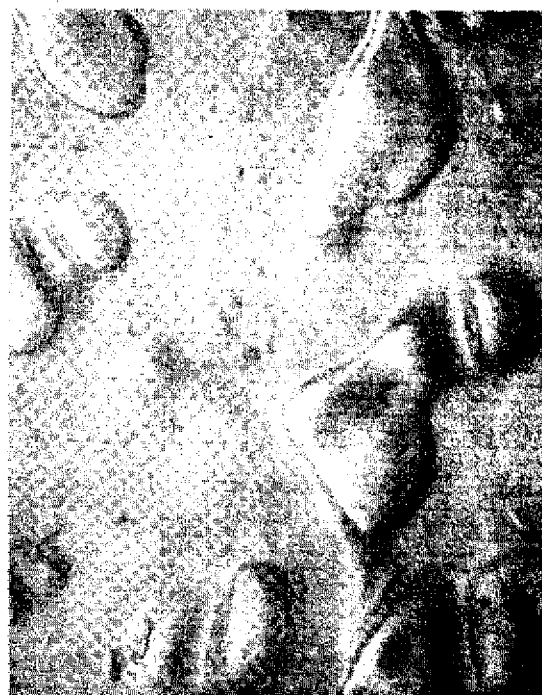
Fig. 4 - Photomicrograph from the epoxy side of the epoxy/glass interface showing the epoxy/nylon-cloth/nitrile-elastomer composite adhesive. Bonded between two microscope slides at 350°F and 15 psi pressure. (100X; transmitted, oblique light.)

Regardless of this distortion, features of the entrapped bubbles, nylon filament, and the intersection of the nylon filaments with the bubbles are plainly visible.

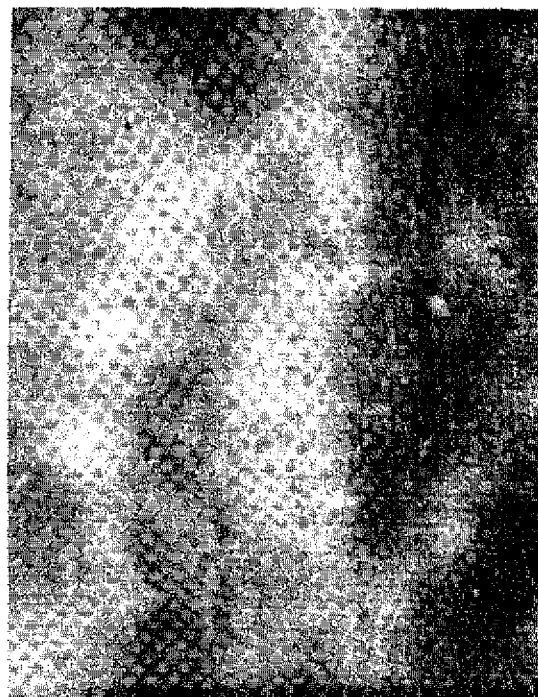
Fig. 8 - Photomicrograph from the elastomer side of the nitrile-elastomer/glass interface showing the epoxy/nylon-cloth/nitrile-elastomer composite adhesive. Bonded between two microscope glass slides at 350°F and 15 psi pressure. (100X; transmitted, oblique light.)

Studies of the nitrile-elastomer side of the composite adhesive did not reveal as many structural features. It was not possible to conclude whether the nitrile adhesive completely wetted and covered the glass surface in every instance, although it appeared that it had in many cases. Figure 5 is a low-power photomicrograph of the nitrile-elastomer side as seen by transmitted light. The bubbles appear to be substantially below the interface and apparently are the same ones observed from the epoxy side. However, in another slide, bubbles or voids were seen which appeared to be at or near the glass/nitrile adhesive interface. These can be seen in Figs. 6 and 7. It is not possible to determine the depth of these voids, but it appears that some are quite deep and may extend through the bond to the epoxy/glass interface. The photomicrograph in Fig. 8 is

similar to that in Fig. 4 in that a somewhat distorted view results from the type and angle of lighting (transmitted, oblique). In this particular instance, the microscope is focused below the interface and the view is through a thin layer of the nitrile adhesive. The shadow areas are the entrapped "air" bubbles in the adhesive matrix.

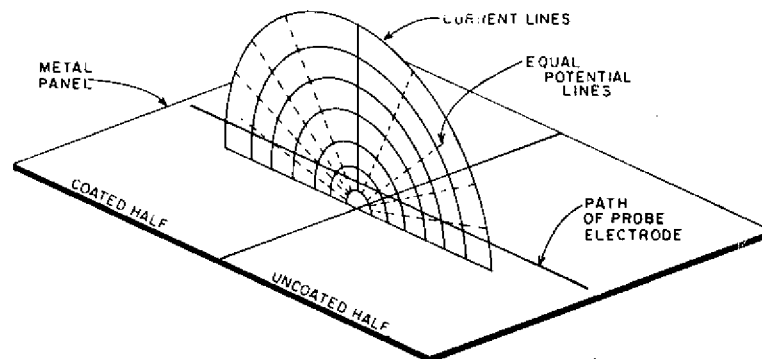
Fig. 9 - Electric current and potential distribution in the medium surrounding a corroding half-coated metal panel

The half-coated panel is placed in distilled water and scanned (as shown in Fig. 9) from the uncoated to the coated area a few millimeters above the surface with a probe calomel electrode. A reference calomel electrode is moved along parallel with, and at a constant distance from, the probe electrode. The position of the reference electrode is such that it does not traverse the panel; that is, the position is such that it is unaffected by the corrosion currents and potentials over the panel. As the half-coated panel is traversed by the probe electrode, the potential change is plotted as a function of the position of the probe electrode relative to the uncoated/coated boundary. Since the potentials measured are for the solution above the panel, changing the sign gives the corresponding potential on the surface of the panel.

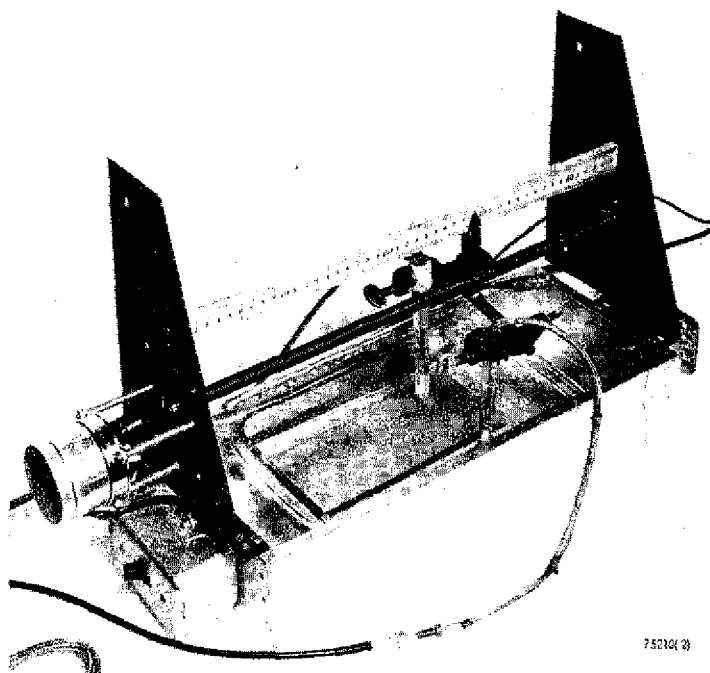
Fig. 10 - Apparatus for measuring the electrical potential distribution of half-coated metal panels in a corrosive medium

The apparatus designed to make these measurements is shown in Fig. 10. The panel under study is placed in the glass tray containing the distilled water. The probe electrode

is positioned a few millimeters above the surface of the panel, while the reference electrode is positioned approximately 2 in. to the side of the panel. The electrodes are approximately 4 in. apart and are mechanically attached to the threaded rod so they move on parallel paths. The electrodes are driven at 1 cm/5 min by a clock motor attached to the threaded rod. The scan is started 5 cm before the boundary and stopped 5 cm past the boundary. The output of the electrodes is fed into a high-impedance Leeds & Northrup millivolt meter which is used to drive a strip chart recorder to give a continuous potential distribution as a function of the distance of the probe electrode from the boundary between coated and uncoated areas of the panel.

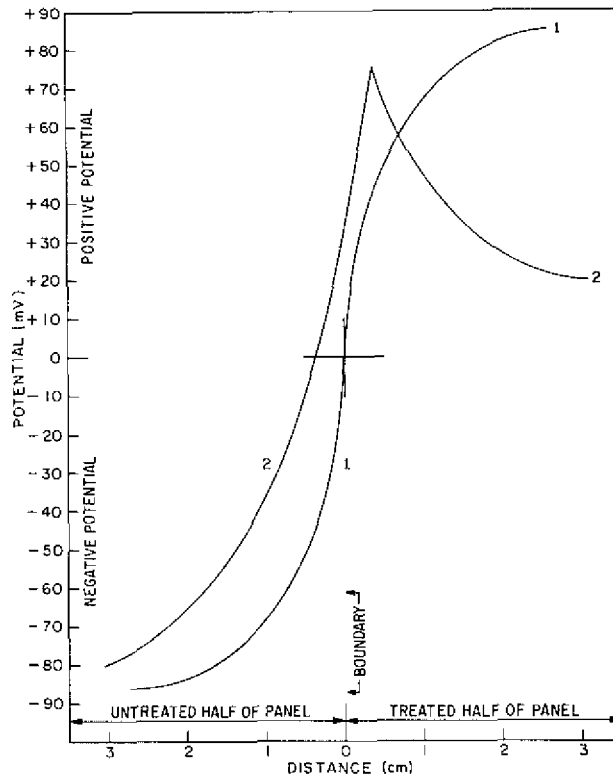
Fig. 11 - Typical electrical potential distribution curves for partially coated metal panels

Figure 11 illustrates two types of curves that can be obtained. Curve 1 is typical of protection that is due purely to the physical barrier of the coating. If the coating were thicker, the curve would have the same general shape, but would be compressed (i.e., electrical potential varies inversely with coating thickness). Curve 2 is characteristic of chemical inhibition, as well as physical inhibition, and is indicative of effective inhibition even a short distance into the uncoated area of the panel. The chemical inhibition is indicated by a change in the S-shape curve; a decrease in the potential value over the anodic region indicates anodic inhibition, while a decrease in the cathodic region, as illustrated in curve 2, indicates cathodic inhibition.

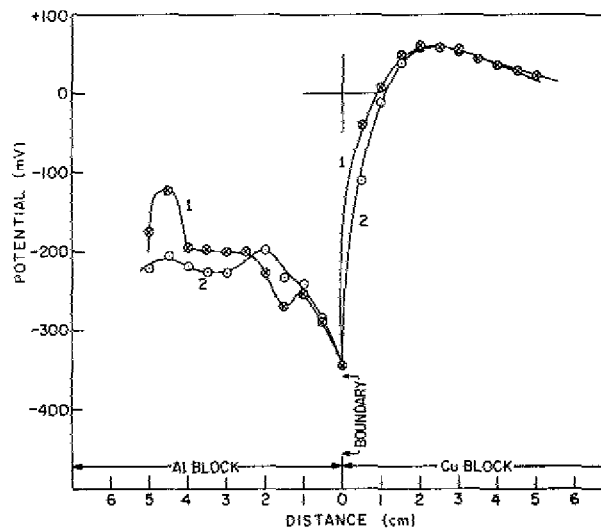
Fig. 12 - Electrical potential distribution of an aluminum-copper couple in distilled-deionized water

in the two runs was that the couple had to be repositioned after the first scan, and therefore on the second scan the probe electrode may not have followed the exact same path across the couple.

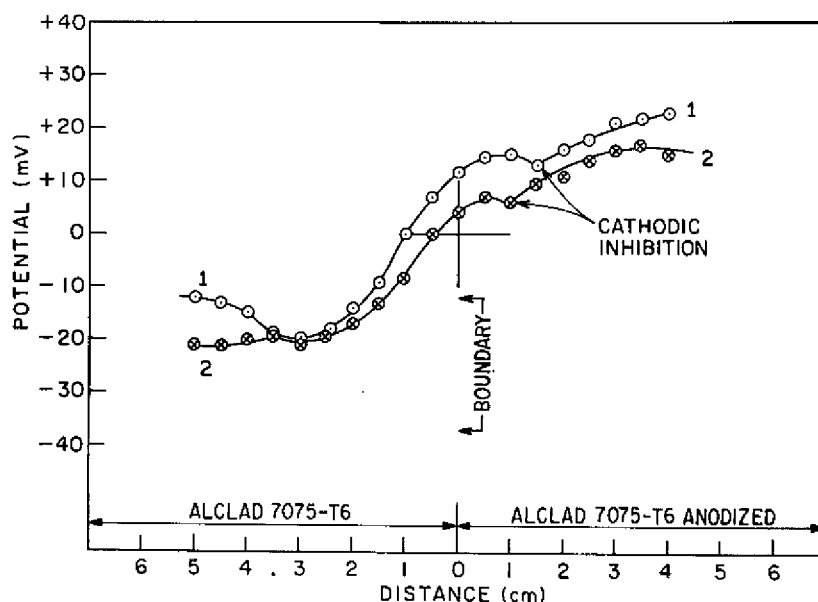
Fig. 13 - Electrical potential distribution of a half-anodized alclad 7075-T6 aluminum panel in distilled-deionized water

In Fig. 13 two potential distribution curves are shown for 7075-T6 alclad aluminum panel, half of which was anodized in a chromic acid bath. The nonanodized alclad area is anodic to the anodized area, and therefore the alclad corrodes. The two curves represent consecutive runs on the same panel in distilled-deionized water. The curves indicate both a physical barrier inhibition and some chemical inhibition. Since the curves are compressed compared to observations made on coated systems, the thin film produced in anodizing would appear to produce a highly effective physical barrier to corrosion. The deviation from the standard S-shape curve in the cathodic and the anodic regions indicates both cathodic and anodic inhibition of corrosion. Further, since the potential becomes cathodic before the probe electrode crosses the clad/anodized boundary, the anodize treatment provides protection in the untreated area near the boundary. The anodic chemical inhibition probably is attributable to chromate ions trapped in the coating during anodizing in chromic acid. This protection from corrosion in the boundary region of half-anodized panels has also been observed on panels exposed in the salt fog. The reason for the slight cathodic inhibition is not known.

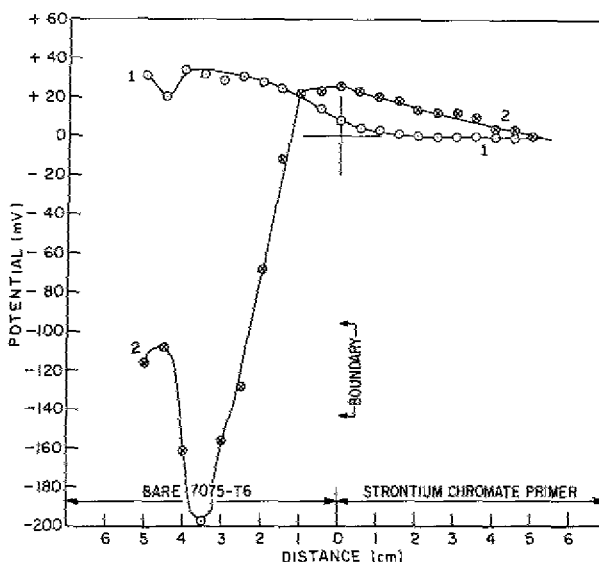
Fig. 14 - Electrical potential distribution of a bare 7075-T6 aluminum panel half coated with a strontium chromate adhesive primer in distilled-deionized water

The importance of the potential-distribution curve during active corrosion is illustrated with the aluminum panel half coated with a strontium chromate anticorrosive adhesive primer. In Fig. 14, curve 1 shows the potential distribution of the coated panel 24 hr after preparation but before exposure to a corrosive medium, while curve 2 is the potential distribution of the panel after exposure to a salt fog overnight. Both measurements were made in distilled-deionized water. If the panel is soaked in distilled water and rinsed several times, the potential distribution again becomes very similar to curve 1. The shape of curve 2 indicates that the adhesive primer anodically inhibits corrosion.

In addition, the primer also provides corrosion protection for the uncoated metal at a substantial distance from the boundary. This protection has been confirmed experimentally by extended exposure of the test panel to the salt fog.

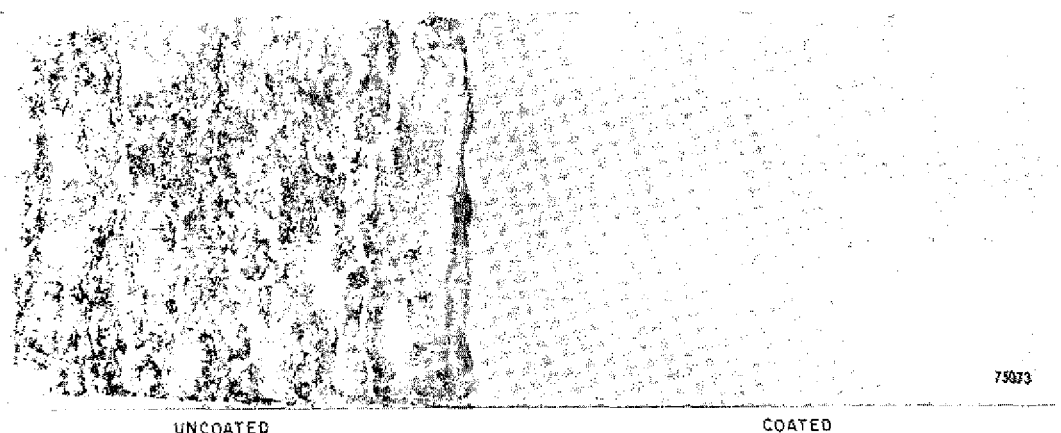
Fig. 15 - Epoxy/polyamid/zinc chromate primer on a bare 7075-T6 aluminum panel after 70 days' exposure to 5% salt fog

The condition of these panels at the end of 70 days is shown in Figs. 15 through 22. The photographs show discoloration in some parts of the score marks. The cause of this discoloration is probably due to the attack of $(OH)^-$ ions which are produced in the cathodic reaction

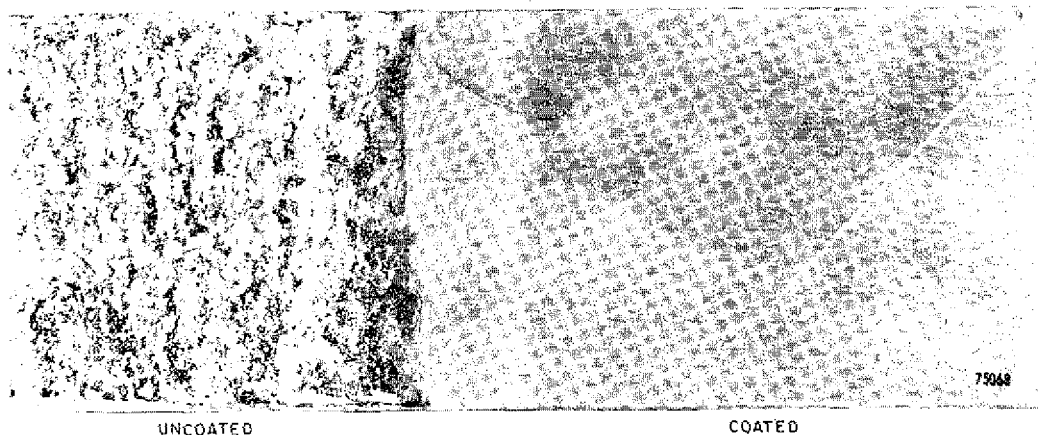
Fig. 16 - Epoxy/polyamid/strontium chromate primer on a bare 7075-T6 aluminum panel after 70 days' exposure to 5% salt fog

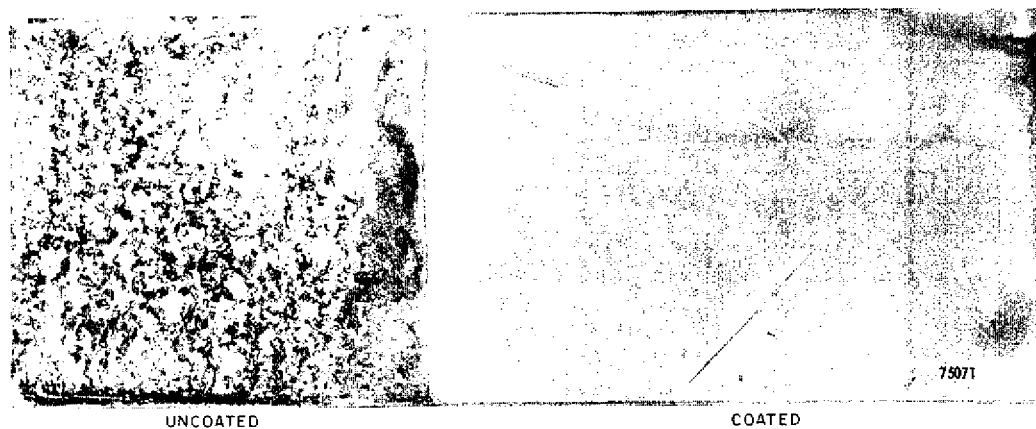
Fig. 17 - Epoxy/polyamid/calcium chromate primer on a bare 7075-T6 aluminum panel after 70 days' exposure to 5% salt fog

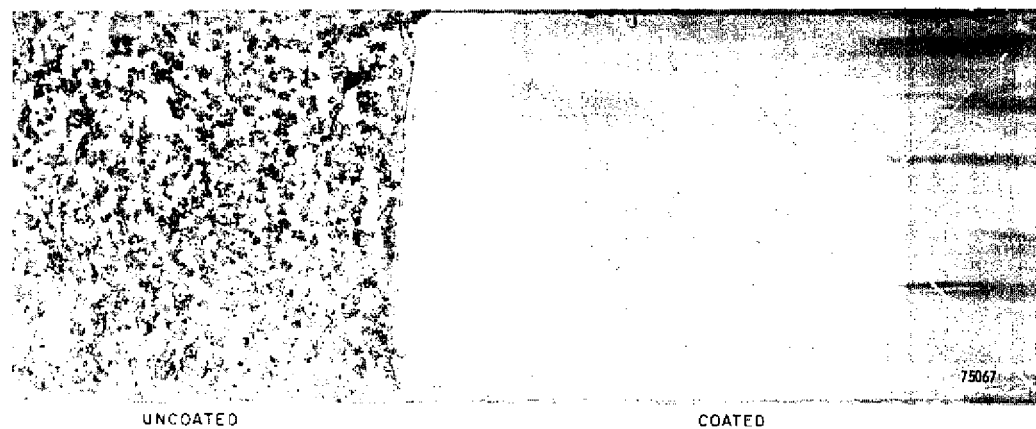
Fig. 18 - Epoxy/polyamid/zinc tetroxychromate primer on a bare 7075-T6 aluminum panel after 70 days' exposure to 5% salt fog

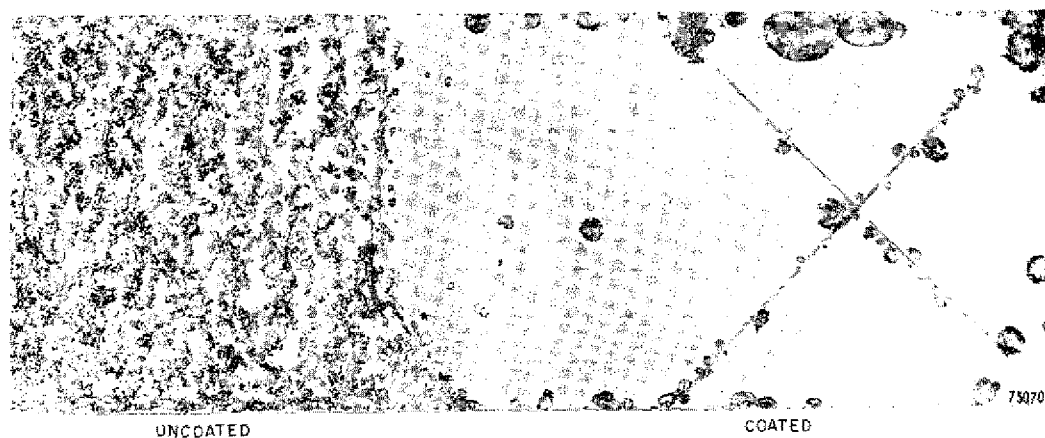
Fig. 19 - Epoxy/polyamid/aluminum silicate primer on a bare 7075-T6 aluminum panel after 70 days' exposure to 5% salt fog

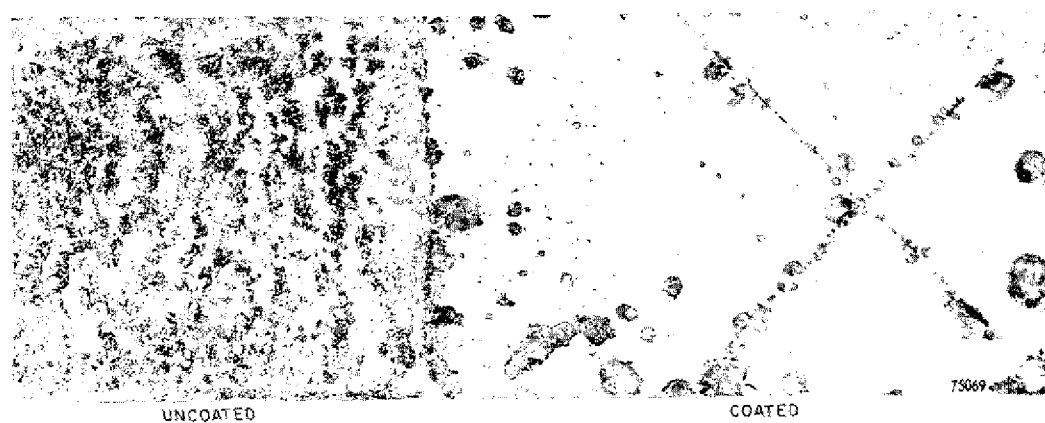
Fig. 20 - Epoxy/polyamid/magnesium silicate primer on a bare 7075-T6 aluminum panel after 70 days' exposure to 5% salt fog

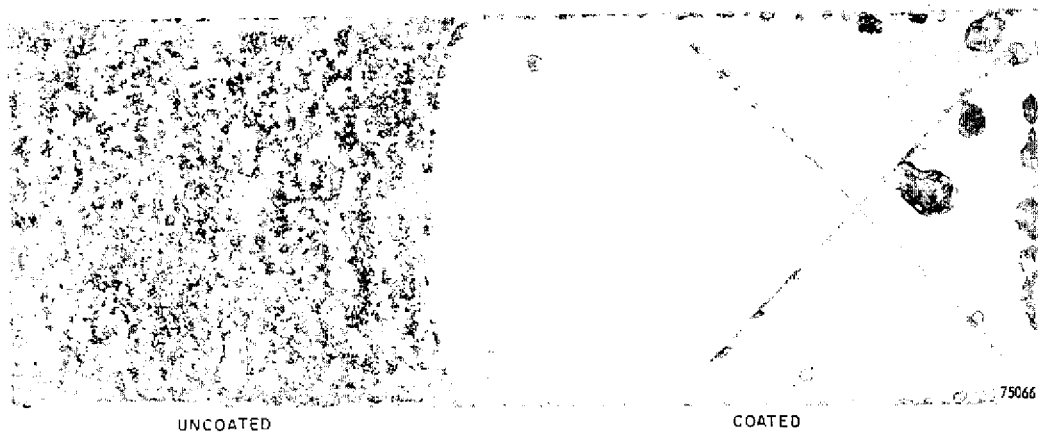
Fig. 21 - Epoxy/polyamid/silica primer on a bare 7075-T6 aluminum panel after 70 days' exposure to 5% salt fog
